NBSIR 82-2465

Investigation of the Kansas City Hyatt Regency Walkways Collapse

February 1982

**INVESTIGATION OF THE KANSAS CITY
HYATT REGENCY WALKWAYS COLLAPSE**

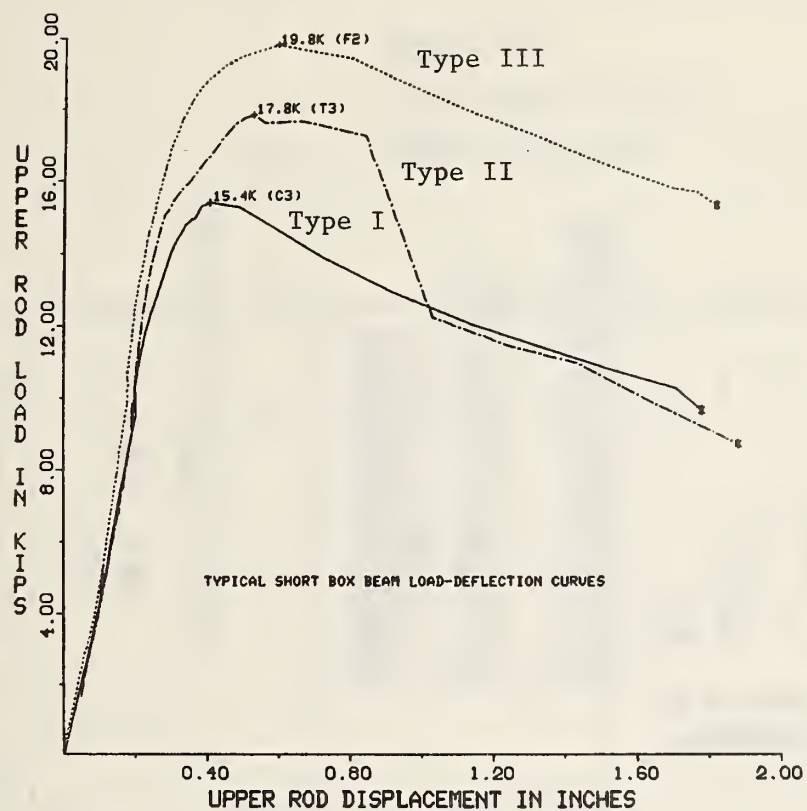
Three typical in-plane load-deflection curves for the short box beam specimens are shown in figure 6.15. (A complete set of load-deflection curves is presented in appendix A.6.10.) Each curve is a plot of the load measured by the upper rod load transducer versus the displacement of the rod measured by the LVDT at the box beam terminus of the upper loading rod (LVDT no. 2 in figure 6.13). The peak load achieved by each of the specimens is shown on their respective curves. The asterisk on each curve indicates the end of reliable measurement by the displacement device and does not necessarily denote final rod pull-through.

The in-plane load-deflection curves in figure 6.15 illustrate specimen behavior usually associated with failure types I, II, III and are again illustrated by specimen C3, specimen T3, and specimen F2, respectively.

Figure 6.15 In-plane load deflection curves for specimens C-3, F-2, and T-3.

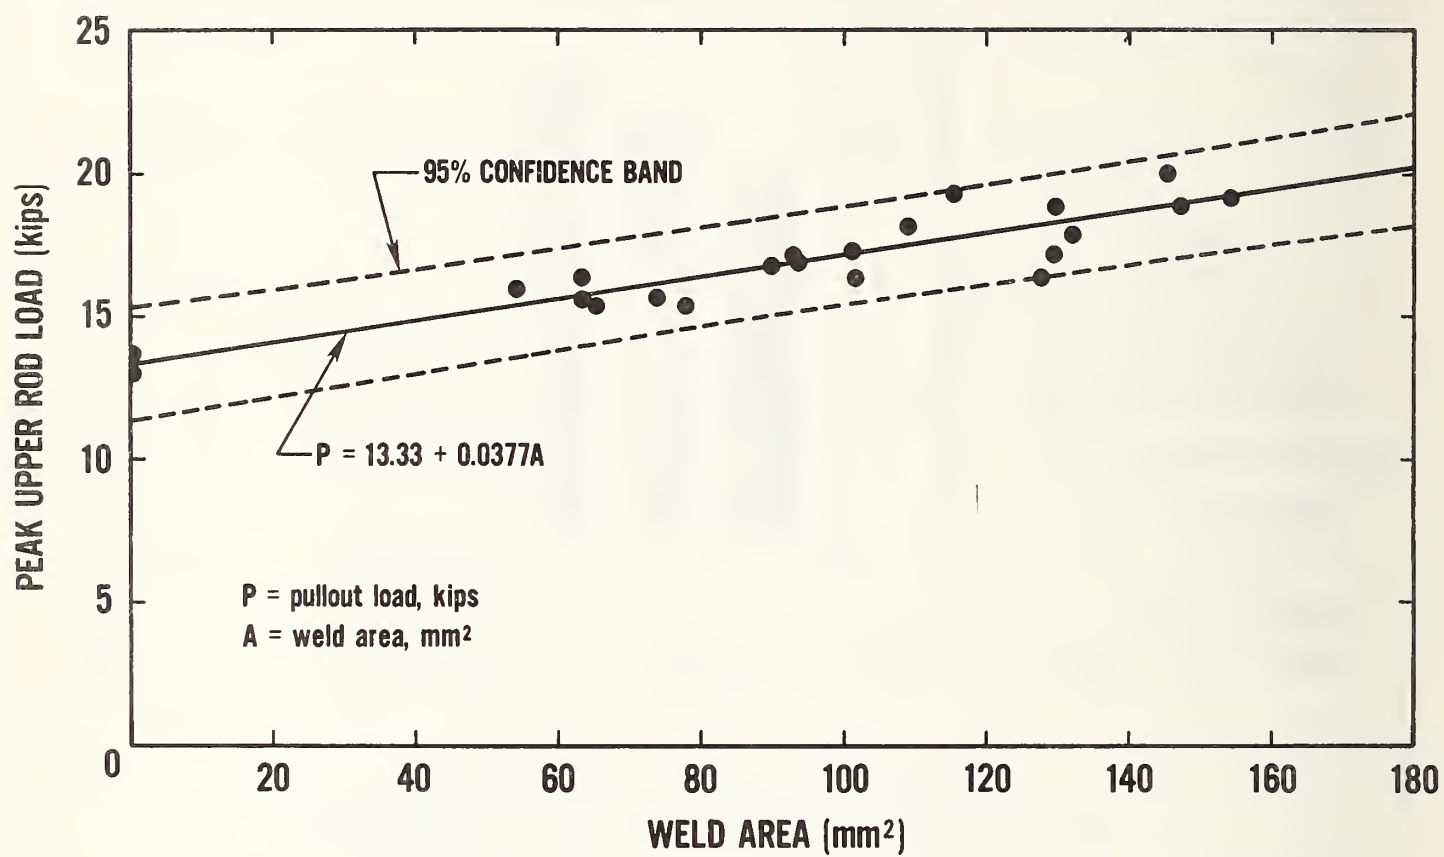
The data shown in figure 6.20 include all tests on short box beams with hardened washers as listed in table 6.1 except for round nut bevel, initial rod load, single rod and clip angle presence. These latter parameters are discussed in section 6.10.5.

Figure 6.20 Effect of weld area on peak load, hardened washers.

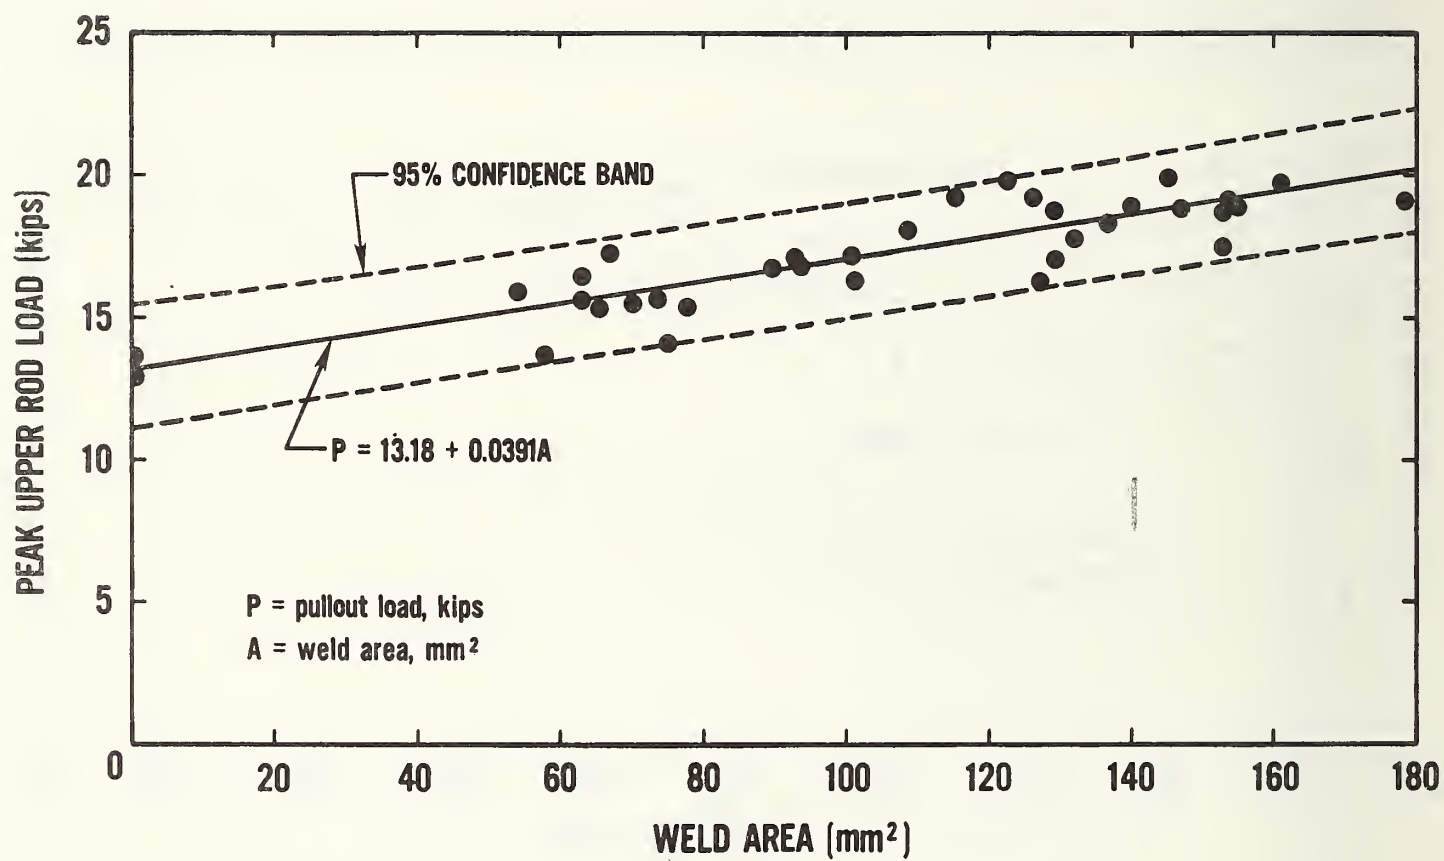
Figure 6.31 Effect of weld area on pullout load for NBS tests.

Although these comparisons indicate that the regression analysis based on the data shown in figure 6.31 reflects the trend of the walkway data, the walkway section is slightly heavier than the section used in the NBS tests, as shown in table 6.6. Thus, somewhat greater ultimate strength might be anticipated for the walkway cross-sections. This heavier cross-sectional area may explain why the test data fall essentially between the average and the upper portion of the confidence band with none below (recall that KC4 was tested with an unhardened washer).

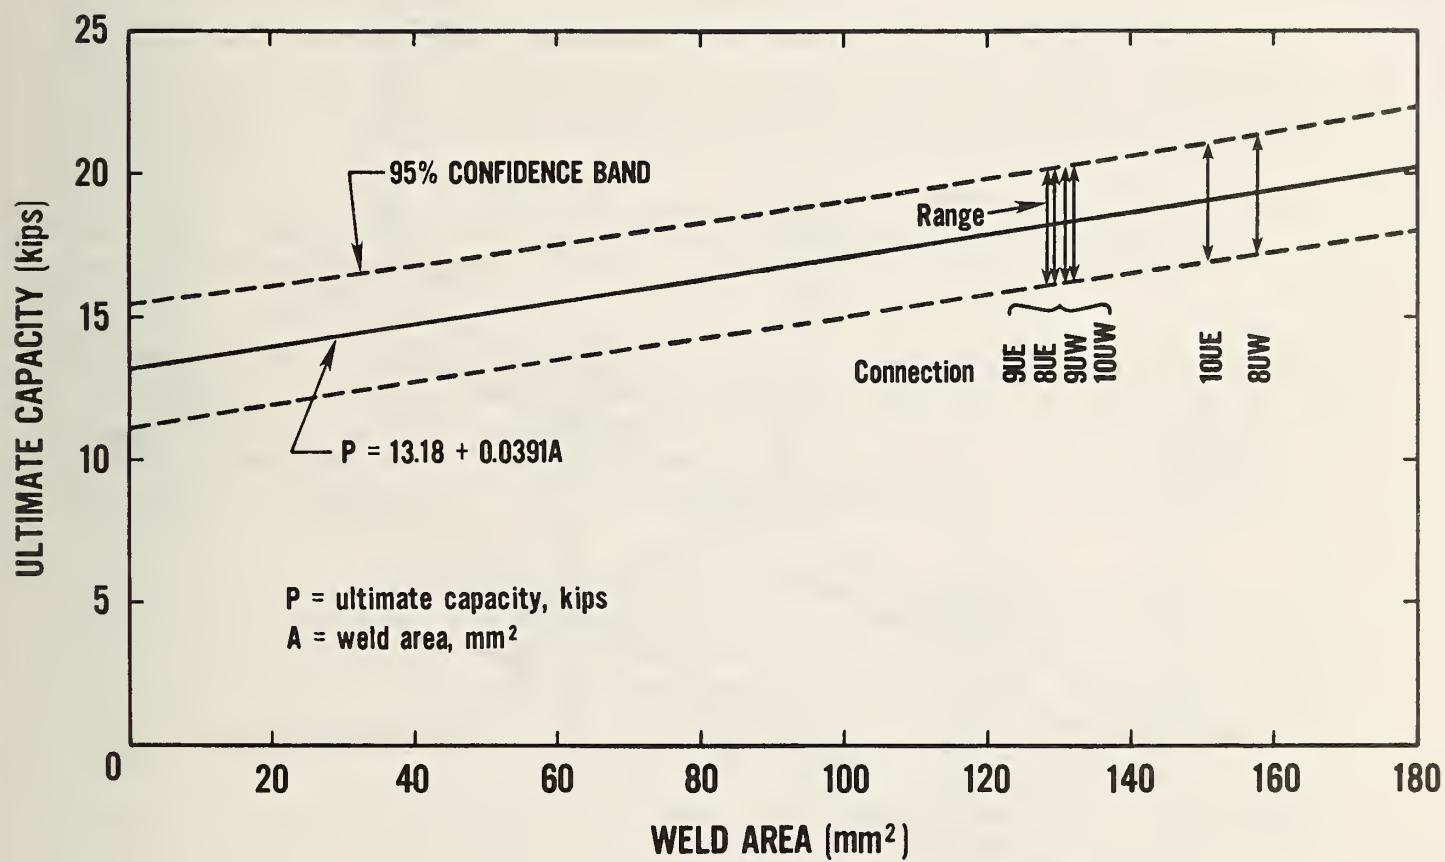
Figure 6.38 Estimated ultimate capacity for walkway box beam-hanger rod connections.

The meaning of figure 6.38 is amplified by discussing box beam-hanger rod connection 9UE as an example. Simply described, if many specimens like 9UE were tested, their average should fall close to the regression line. However, for a single test one can be 95 percent confident that the test result would fall within the 95 percent confidence band. Thus each connection should be thought of in terms of the range of ultimate strength as well as the average.

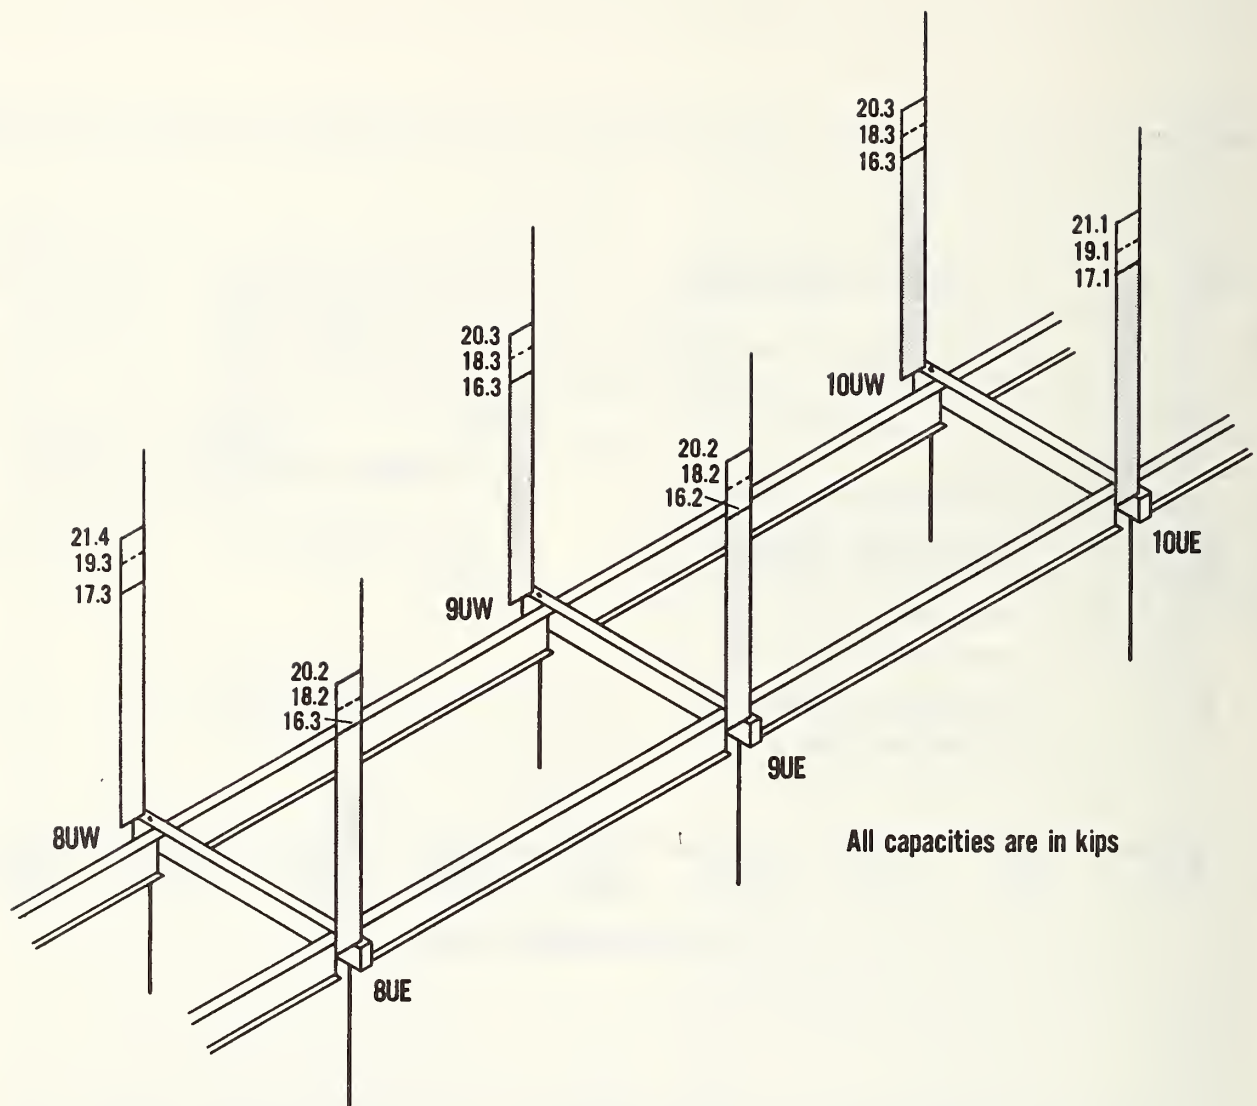
Figure 6.39 Summary of ultimate capacities.

These ultimate capacities are summarized in figure 6.39 on a layout of the six box beam-hanger rod connections. A bar diagram is shown adjacent to each hanger rod. Location 8UE is described to denote the meaning. The range from 16.3 to 20.2 kips (73 to 90 kN) is the 95 percent confidence interval estimate

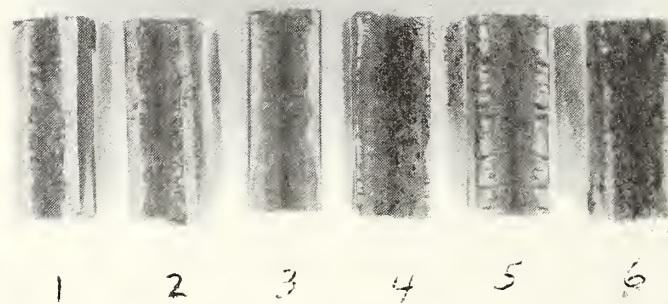
Variation in the transverse strength of the walkway box beam longitudinal welds was determined by testing 1.0 in (25.4 mm) wide tensile coupons to failure. Weld caps were machined flush to simulate conditions near the beam ends. The results, summarized in table 7.5, show a substantial variation in breaking load among specimens taken from the same beam. The observed variability is not unusual for the type of weldment tested considering the small weldment area sampled by each specimen. Figure 7.9 shows the variability in the amount of weld metal from specimen to specimen at the fracture. This variability correlates reasonably well with the specimen breaking loads (table 7.5). Differences in the amount of porosity found on the fracture surfaces of the specimens also contribute to the ultimate strength variation.

Figure 7.9 Fracture surfaces of walkway weldment tensile specimens. Both halves of each fracture are shown. The bright regions represent fracture and indicate the depth of weld penetration. Specimen key is as follows. X1

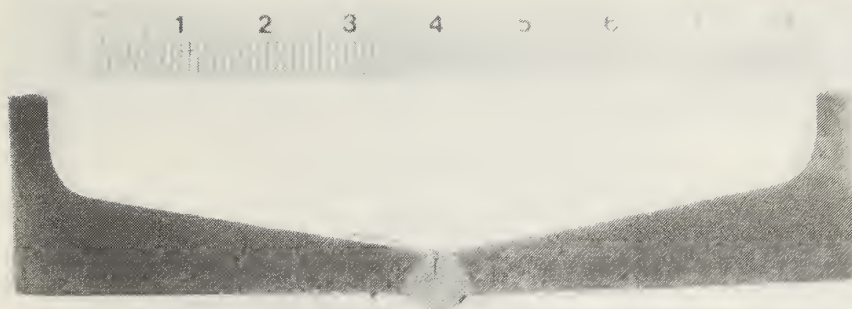
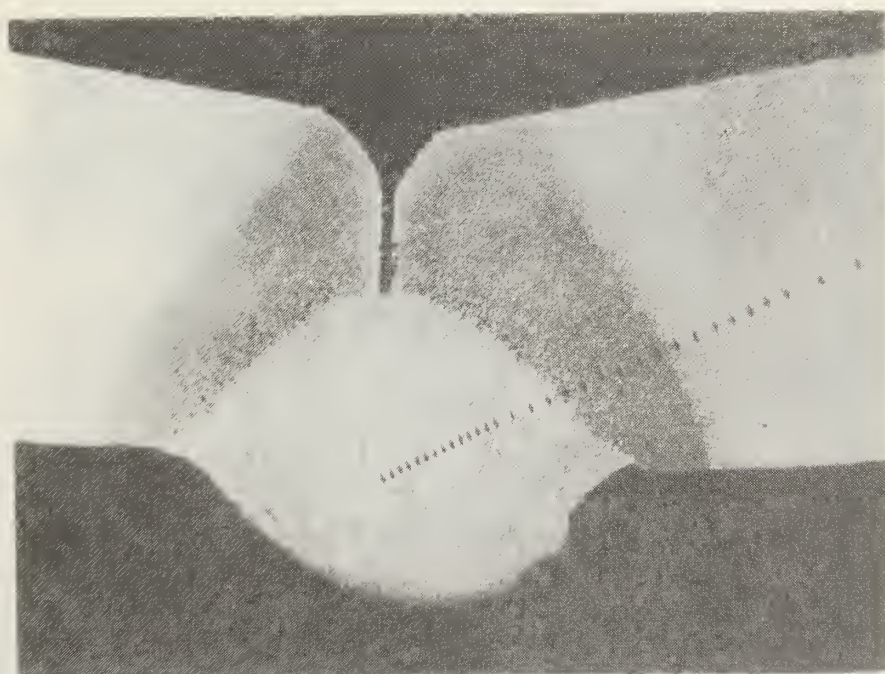
Figures 7.10 to 7.13 illustrate a substantial variability in the contour of the mating flange ends forming the faying surfaces for welding. The effect, coupled with differences in weld penetration, creates regions of varying notch acuity in the weld region. However, no cracks were observed to have initiated from such notches in any of the sections studied.

Figure 7.10 Transverse section through NBS weldment IC welded by the GMAW process. Dark regions separating weld metal from flange base metal are heat-affected portions of base metal. Aligned indentations are microhardness measurements. a, X1; b, X8 1/2

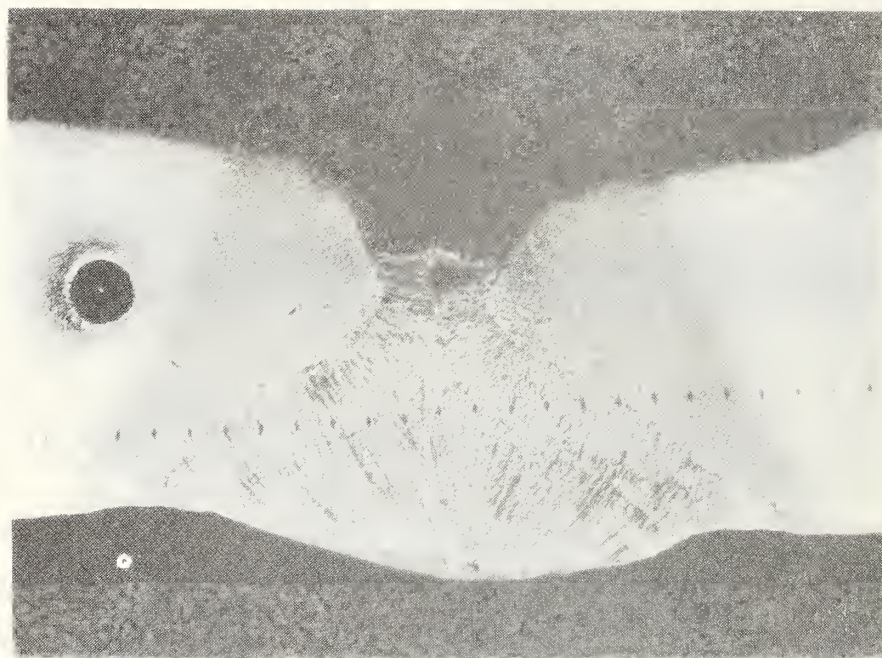
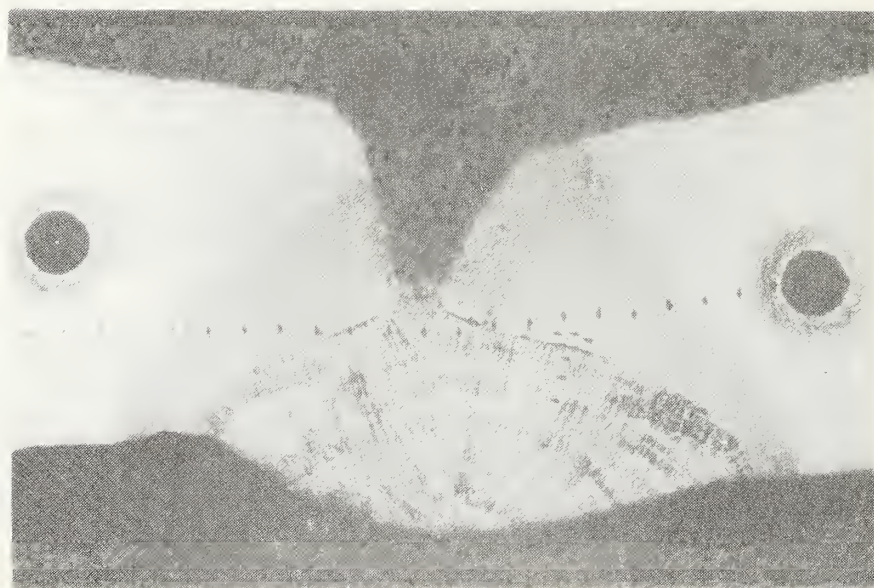
Figure 7.10 illustrates the appearance of an NBS weldment made by the GMAW process, while figures 7.11-7.13 illustrate the appearance of weld regions in box beams 9U, 8L and 9M, respectively. Basic walkway weldment hardnesses were normal. Maximum hardnesses were 92-95 Rockwell B (HRB) for the weld regions, 85-93 HRB for the heat-affected zones and 70-79 HRB for the unaffected parent metal. Small zones of increased hardness (28-33 HRC) were noted in the heat-affected zones of one section taken from location 9U and one section taken from location 8L. The structure of the hard zones appeared to be tempered martensite.

Figure 7.11 Cross sections through weld regions of box beam 9U (NBS 1). Sections were separated about 7 in (180 mm) along the beam length. Microhardness indentations traverse the surfaces.
X 8 1/2

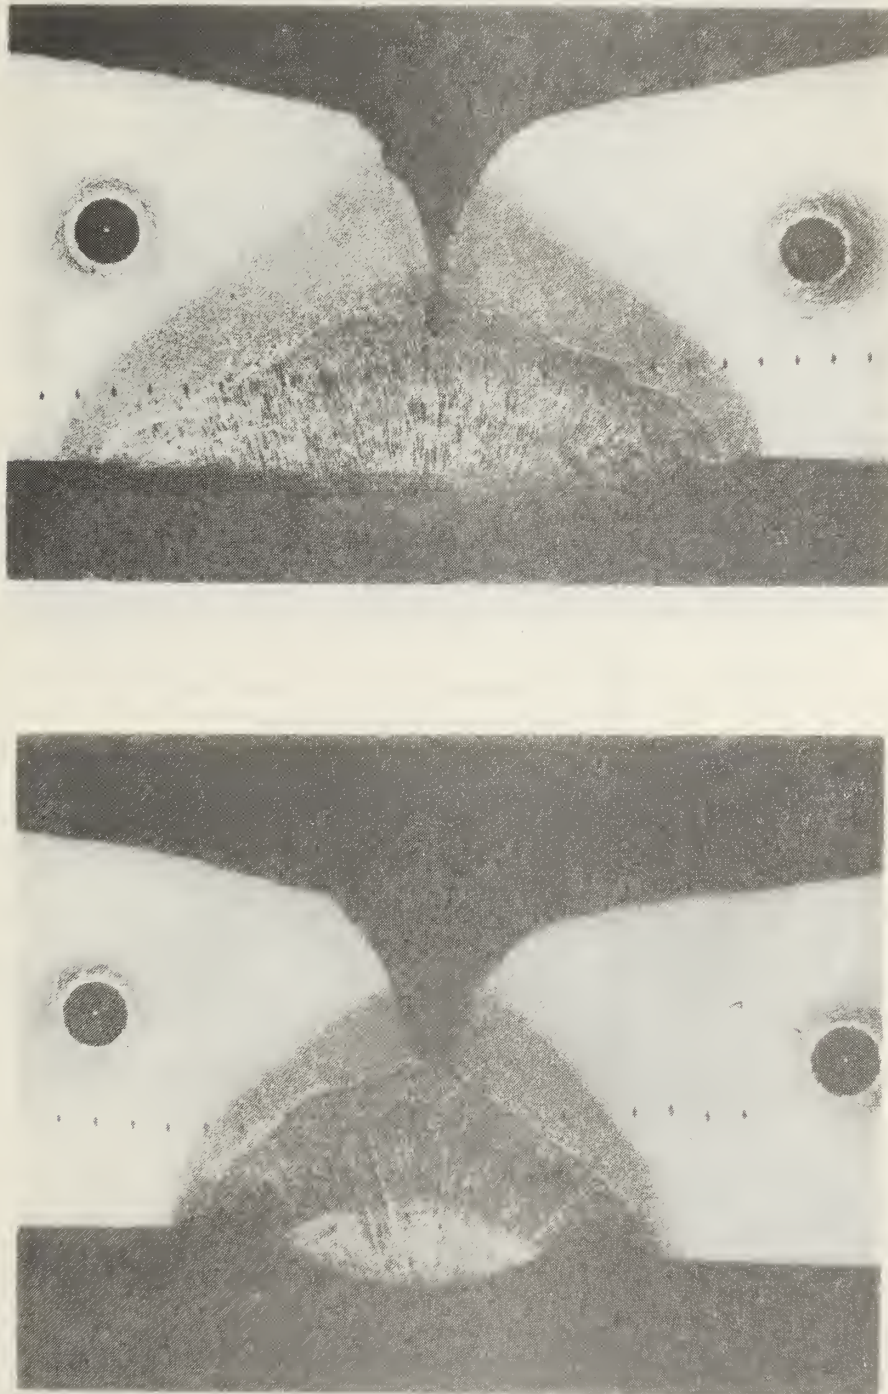
Figure 7.12 Cross sections through weld regions of box beam 8L. Sections were separated about 7.5 in (190 mm) along the beam length. Microhardness indentations traverse the surfaces. X8 1/2

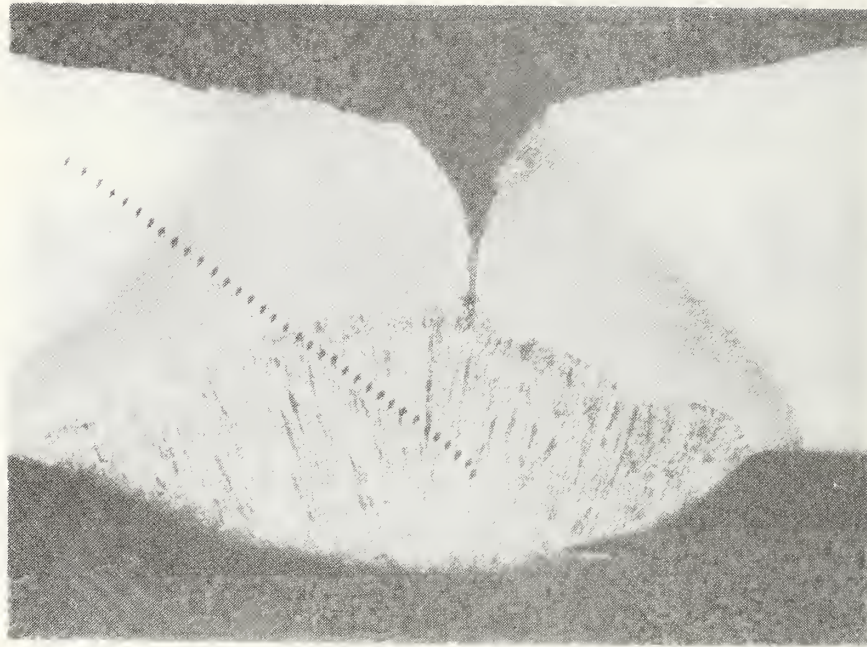
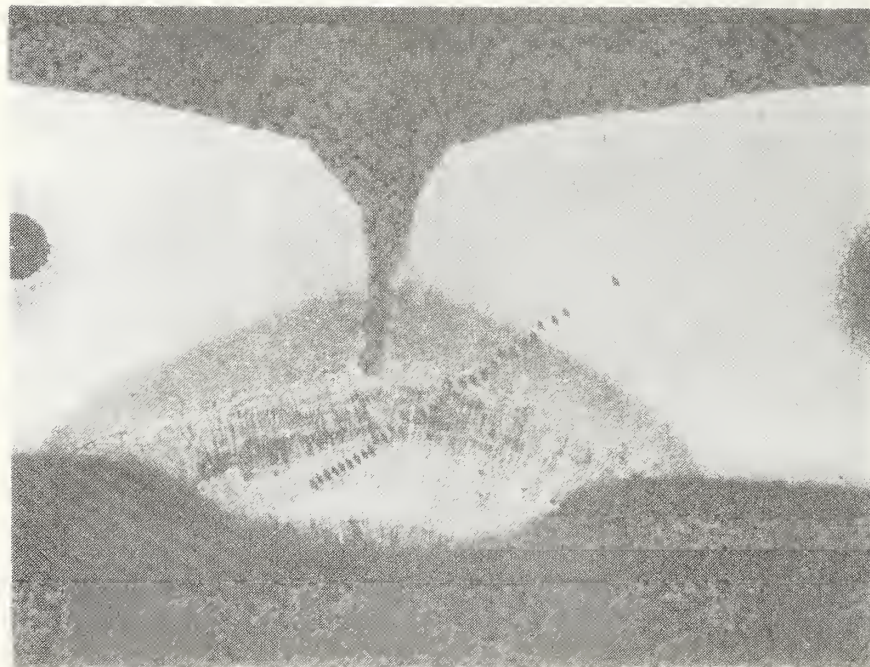
Figure 7.13 Cross sections through weld regions of box beam 9M. Sections were separated about 7.5 in (190 mm) along the beam length. Microhardness indentations traverse the surfaces. X8 1/2

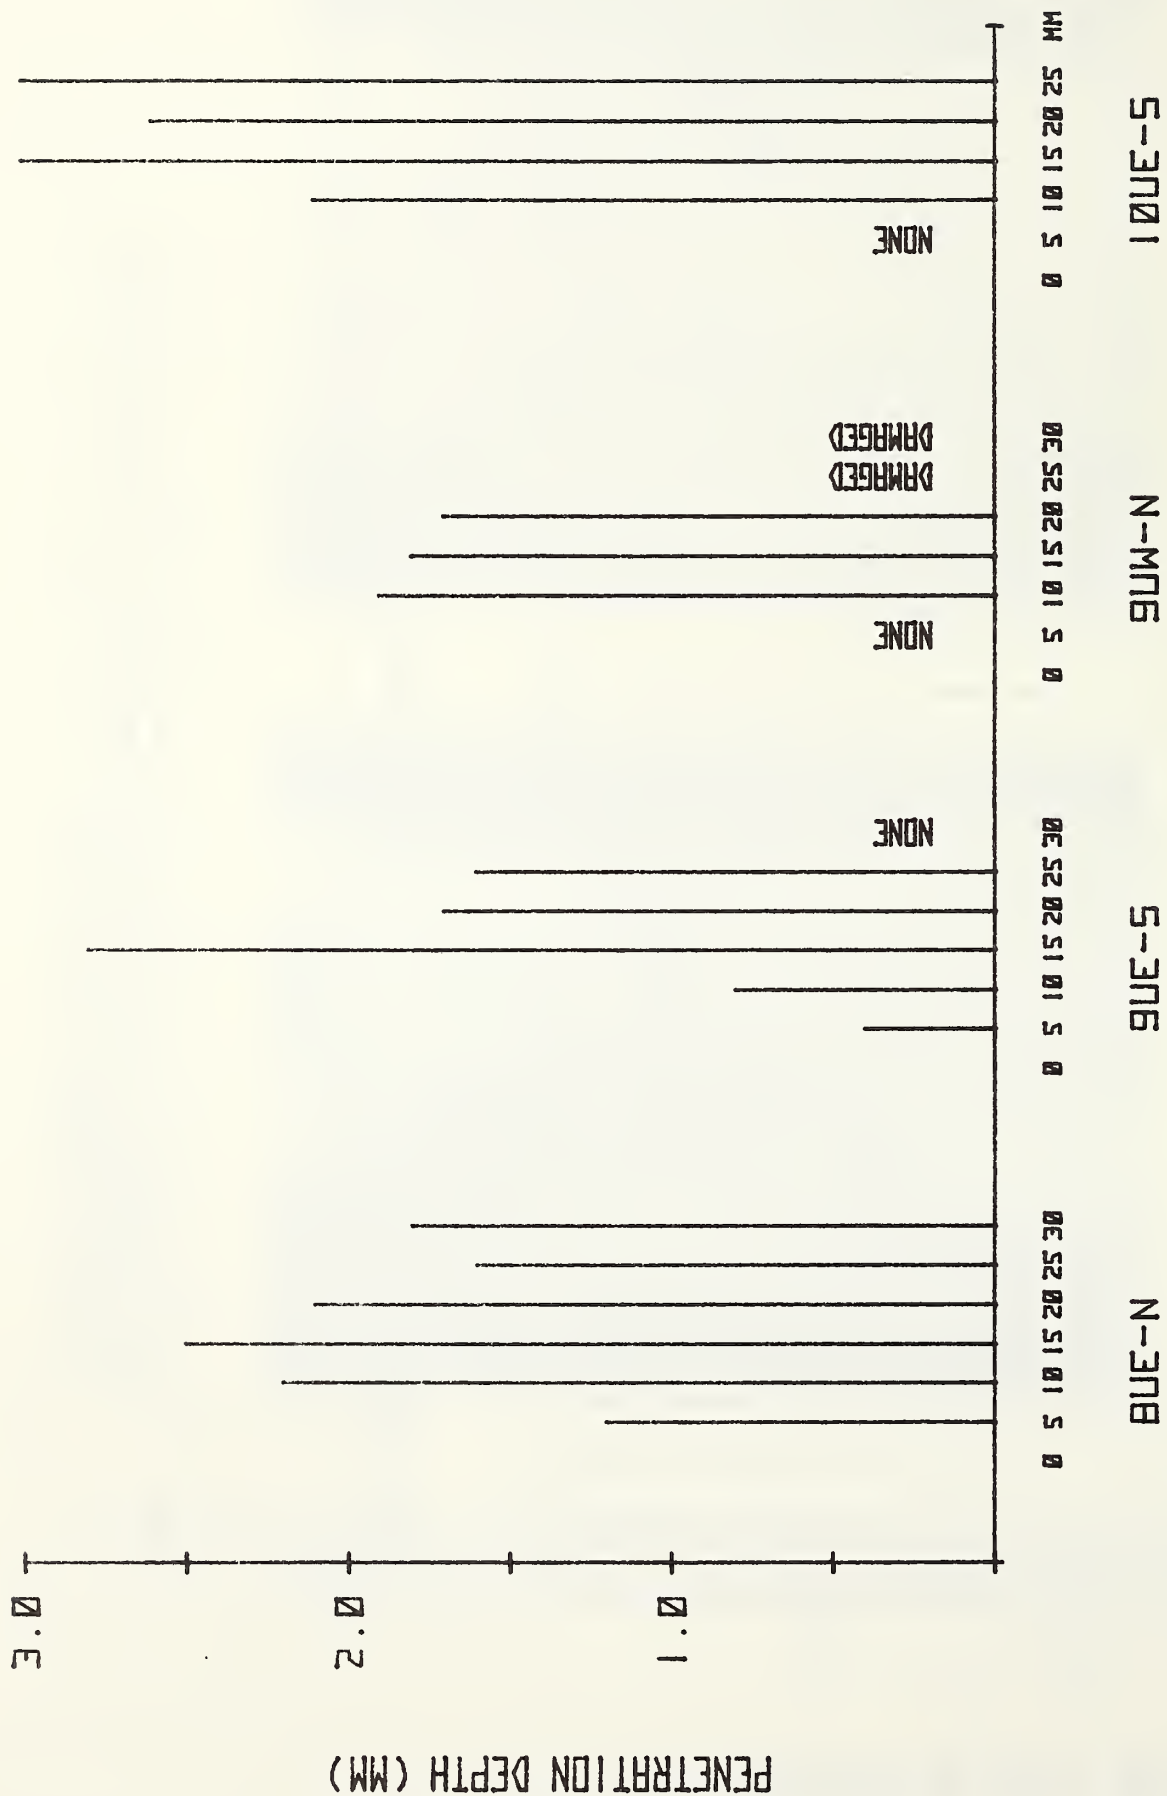
Interior tack welds were present at the bottom flanges of all beam ends examined. The location of these welds relative to the beam ends and their approximate overall depth as measured from photographs of the fractures are shown in figure 7.15. Estimates were made of the total area of interior tack weld plus the longitudinal weld in the box beam length between the outer hanger rod hole and the box beam end. The data in table 7.6 were compiled by measuring the penetration depth of the longitudinal and tack welds along the fractures at

Figure 7.15 Overall depth of interior tack welds measured from fractures with data points reflecting equally spaced measurements from beam end (left) to hanger rod hole (right). NONE indicates no tack weld at that location.

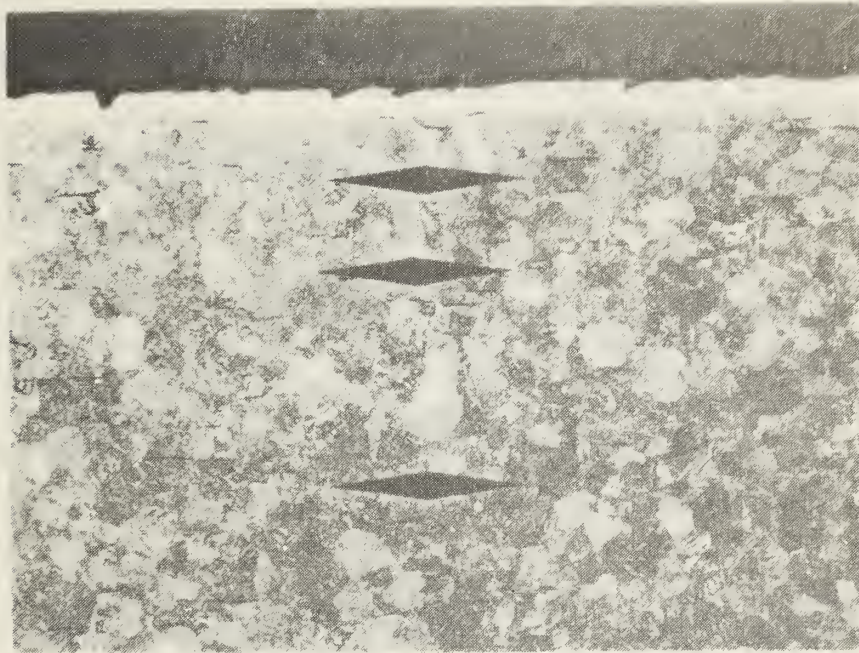
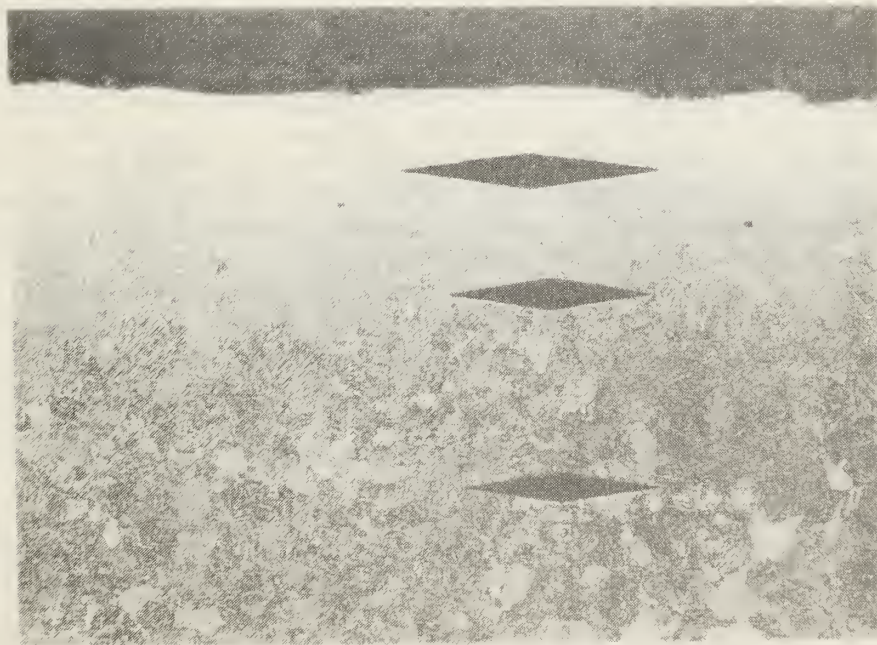
Figure 7.16 Microstructures of washers from 9MW (NBS specimen 3), (a), and of hardened washer used in NBS tests, (b). Whiter layer near surface (top of illustrations) is decarburized layer. Interior structure is tempered martensite. Etchant: Picral. X200

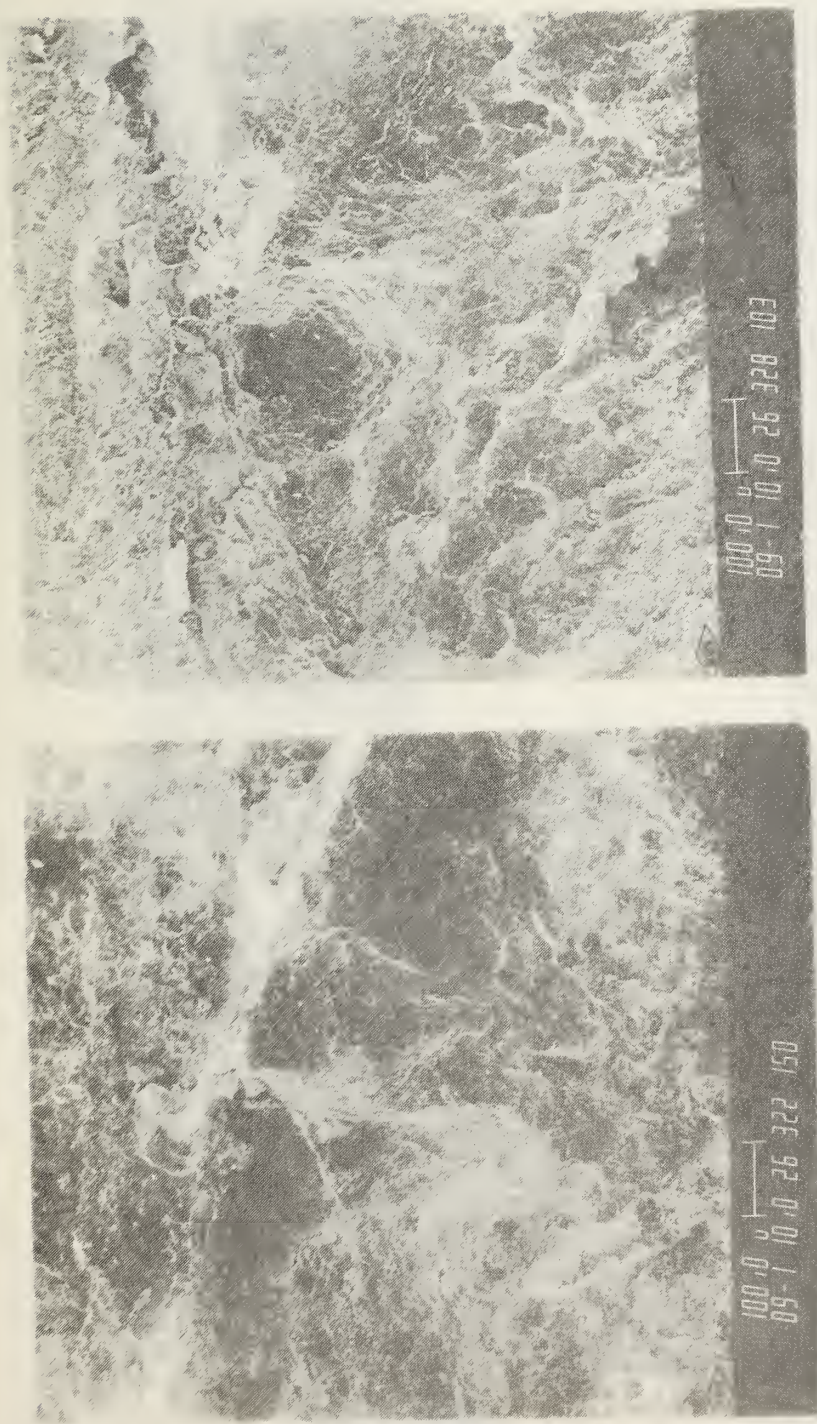
Procedures used to replicate the fracture surfaces have been described in section 5.5. The replication technique is capable of reproducing details of the fracture surface with reasonable fidelity, provided that intimate contact is achieved between the replication media and the surface (figure 8.1). Failure to achieve contact produces artifacts in the replica that must be discounted in the analysis. The replica is a mirror image of the original surface and may have a different sense of image contrast--in one case the image contrast is due to both topography and composition variation (8.1a) and in the other the image contrast is due to topography alone (8.1b). Selection of a specific replica from each surface for study was based on visual evaluation of the largest intact replica contact area and on the least amount of embedded rust and other debris. The replicas were trimmed of excess plastic and attached to a 1 in (25 mm) diameter SEM support stub by a small piece of doublesided adhesive tape. Three point contacts of either carbon or silver paint were then made between the SEM stub and the replica corners to increase their support and to provide electrical contact to the sputter coating later applied to the replicas. A replica identification was also inscribed on the stub at this time.

Figure 8.1 Comparison of quality of image by direct SEM (a) and by replication (b) where replica contact is ideal. Fracture surface is located at root of upper exterior longitudinal weld of walkway box beam at location 8UW (north). Magnification X100.

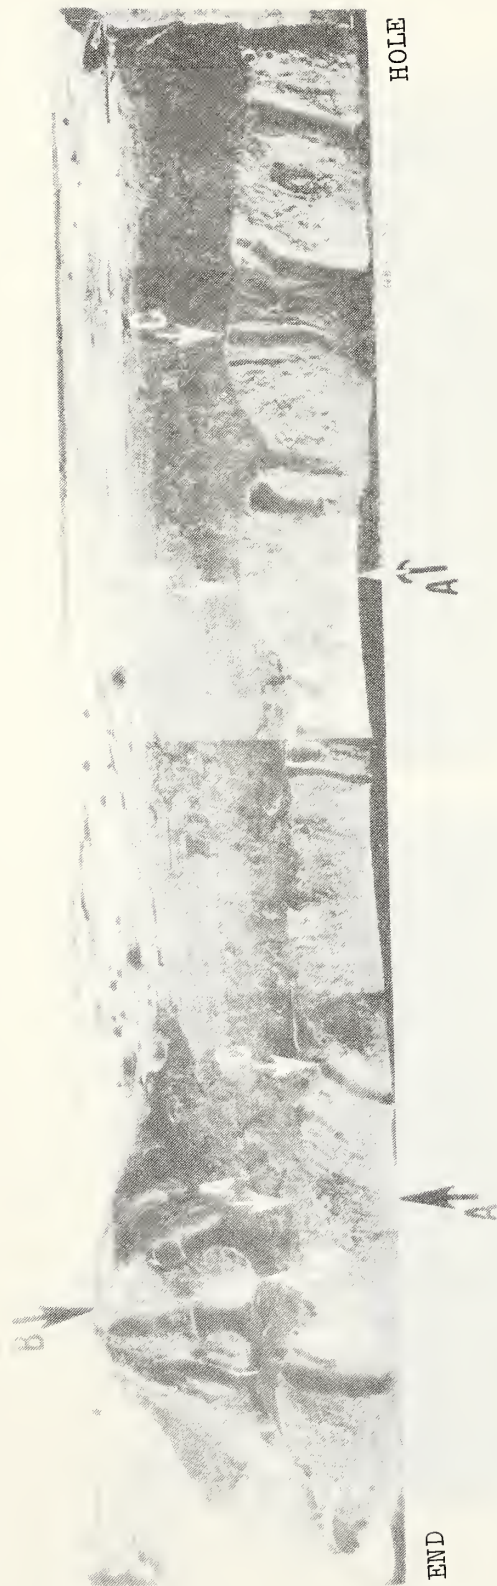
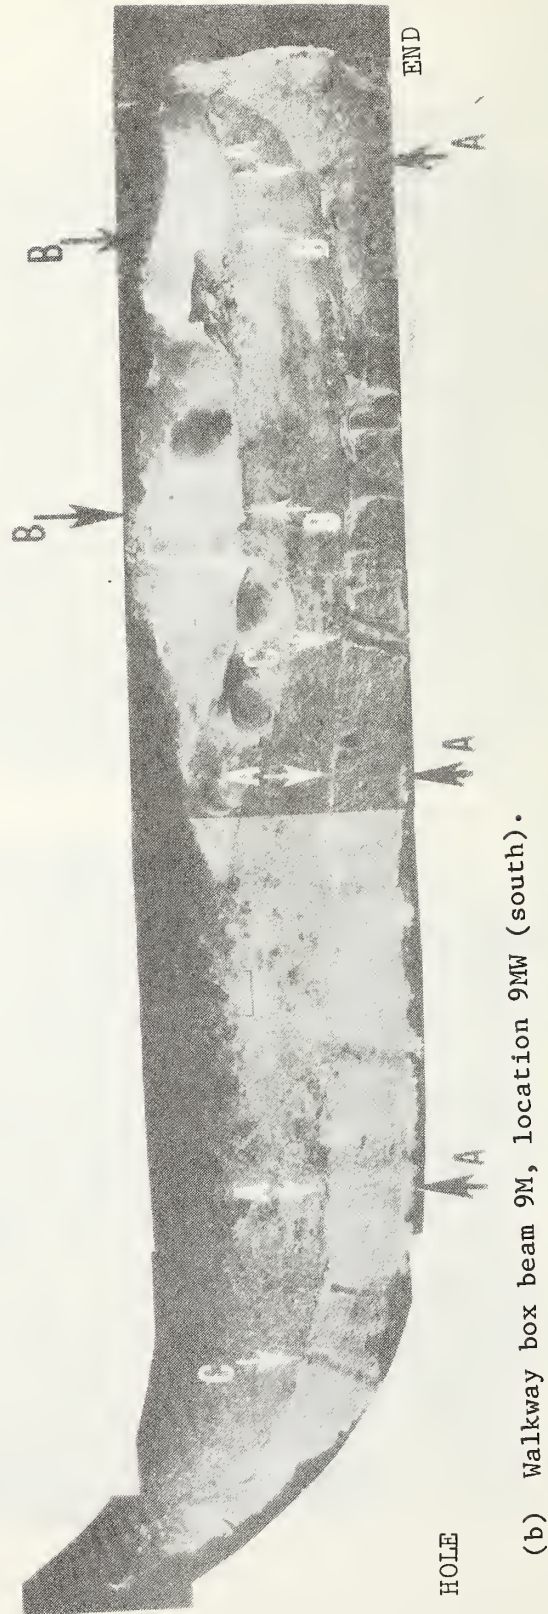
Figure 8.2 illustrates that the gross features of the fracture in the lower longitudinal weld between the outer hanger rod hole and beam end of box beams tested to failure were similar, regardless of whether the beam had been fabricated at NBS or had been obtained from the walkway debris. Rounded and piping porosity are evident in both fractures. The sharply delineated weld region in these figures indicates the absence of rust on the freshly fractured surfaces.

Rounded gas porosity (both large and fine) and piping (elongated) porosity similar to that illustrated in figure 8.2 were evident in the fracture areas of the interior tack and exterior longitudinal welds at locations 8UE, 9UE, 9UW, and 10UE. Fractographic examination indicated that these flaws did not serve preferentially as crack initiation sites. It appears that, in the case of the lower exterior welds, cracks initiated at the root of the weld and propagated through the porosity (figure 8.3). While many of the replicated sections provided reasonable resolution of the fractographic features, figure 8.4 illustrates that in some cases a very tight oxide layer had modified the original fracture surface.

Figure 8.2 One half of box beam fracture surface between beam end and outer hanger rod hole for NBS fabricated box beam K2 (a) and for walkway box beam 9M tested at NBS (b). Exterior longitudinal weld indicated by arrows A, interior tack weld indicated by arrows B, examples of piping porosity indicated by arrows C. Magnification X6.

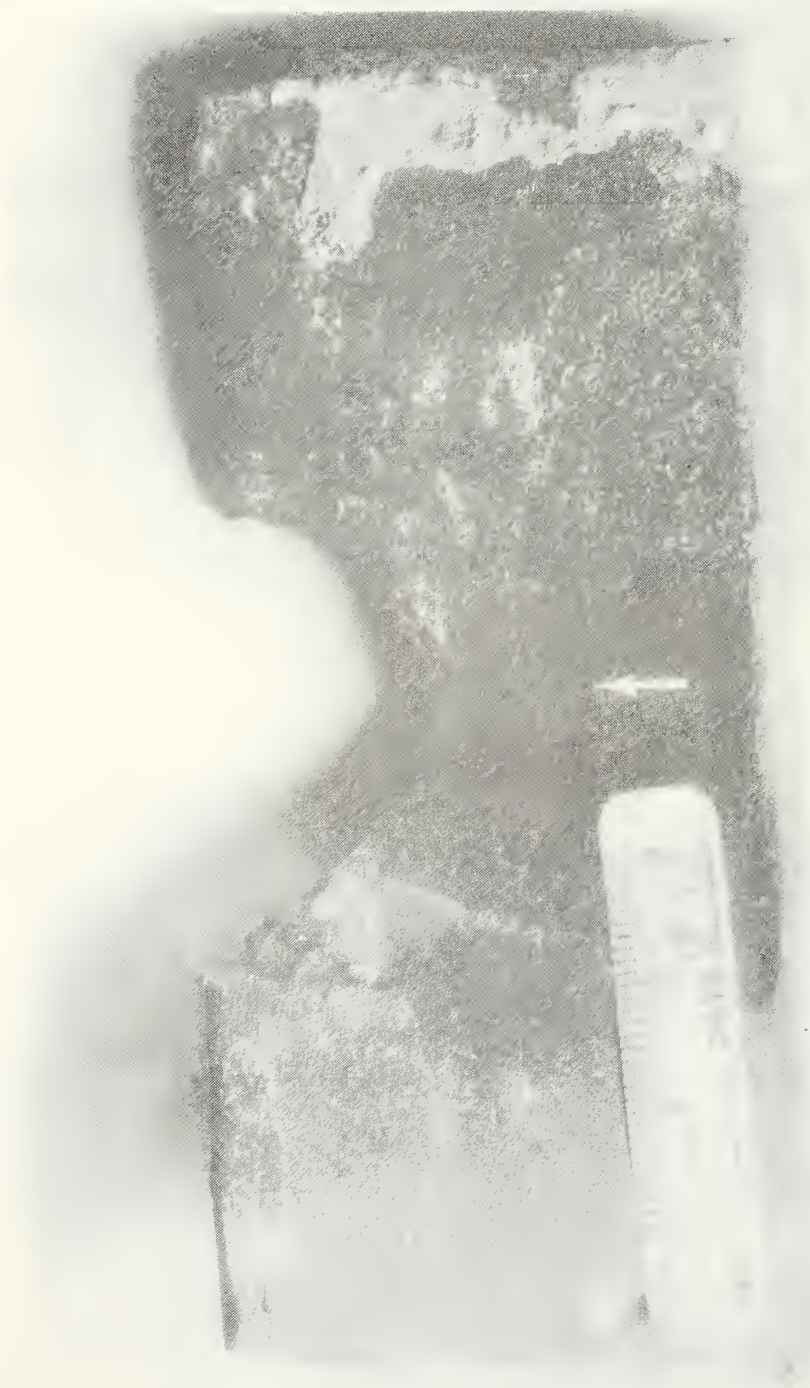
7. Two regions of washer imprints were observed on the bottom surfaces of the box beam flanges. The outermost region contains the imprint of the washer and shows shallow striations. Nearer the hanger rod hole, there was a transition to a more deeply abraded region. This region showed evidence that the failure proceeded in a slip-stick manner.

Figure 8.10 Washer contact region on bottom flange at location 8UE (north).
Arrow denotes initial washer position. Magnification X1.5.

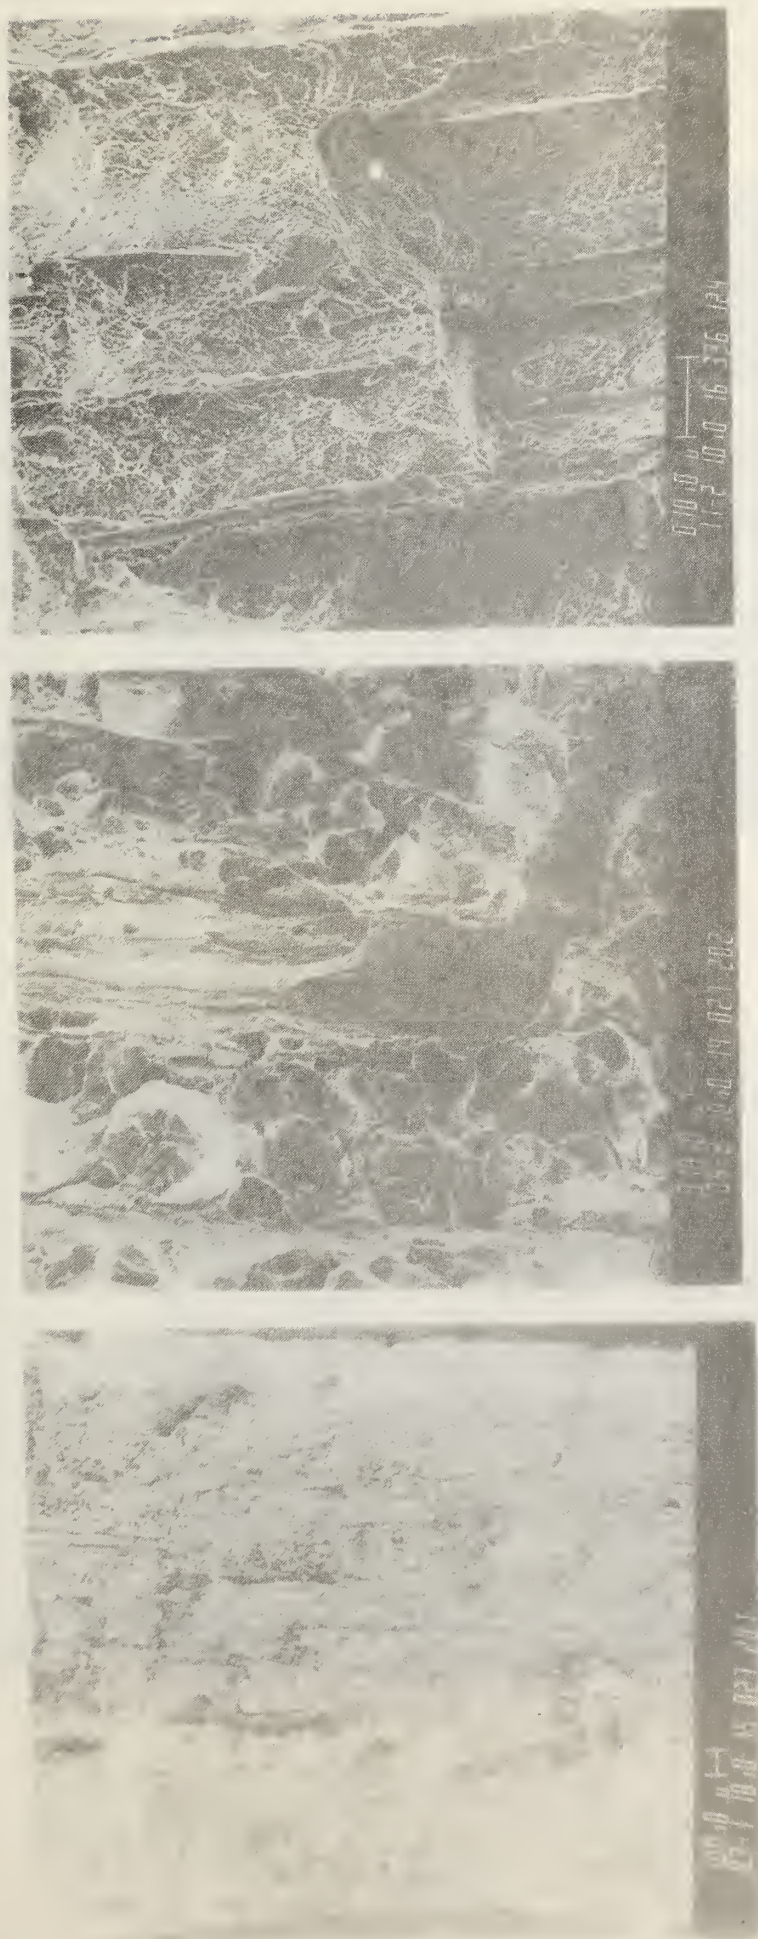
Prominent elongated MnS inclusions can be observed on the fracture surfaces in figures 8.11a and 8.11c. Hardened washers bent around a direction parallel to such inclusions could be expected to display low ductility.

Figure 8.11 Fractographic appearance of hardened washer fractured in NBS test of walkway box beam 9M, washer installed at location 9MW (a). Center portion, area (b), reveals a mixture of brittle (intergranular and cleavage) and ductile fracture. Area (c) reveals ductile rupture through a decarburized surface layer. Elongated features are indicative of MnS stringers. Magnifications (a) X35, (b) X550, (c) X1050.
